Road and Railroad Crossing Inventory

Starkweather Coulee

U.S. Department of the Interior
Bureau of Reclamation
Great Plains Region
Dakotas Area Office

October 2004

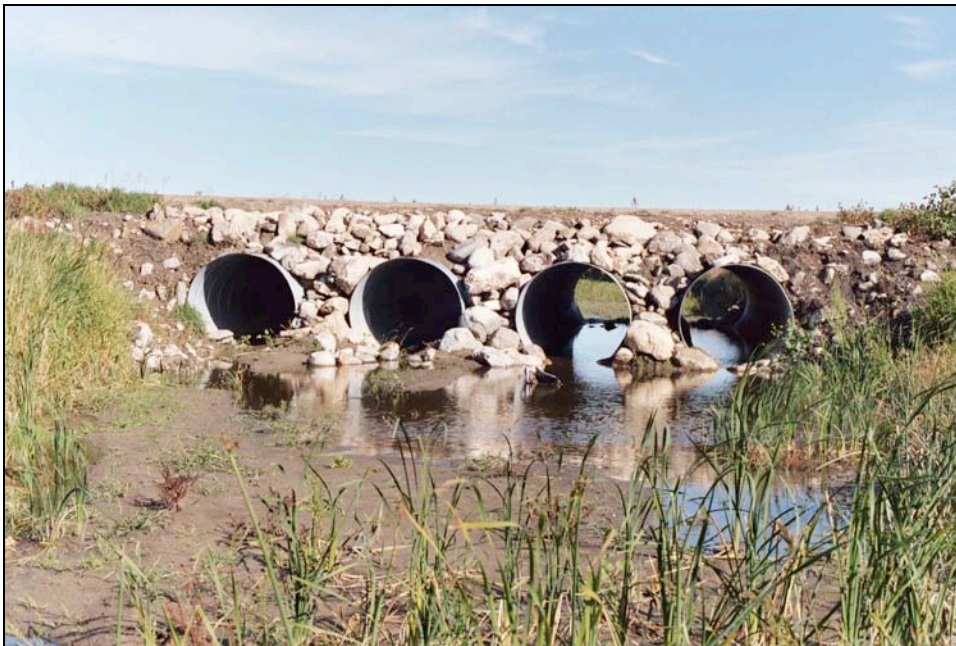
S21 Downstream side of four 60" CMPs, in good condition, 0.6 feet, 0.7 feet, 0.6 feet & no water, from east to west (09-24-04), Section 3 & 4, T157N, R63W,
 N 530915.80, E 2419836.00, elevation 1488.5 @ invert of 60" CMP,
 N 530915.17, E 2419827.21, elevation 1488.4 @ invert of 60" CMP,
 N 530915.64, E 2419818.21, elevation 1488.5 @ invert of 60" CMP,
 N 530915.17, E 2419809.24, elevation 1488.7 @ invert of 60" CMP.

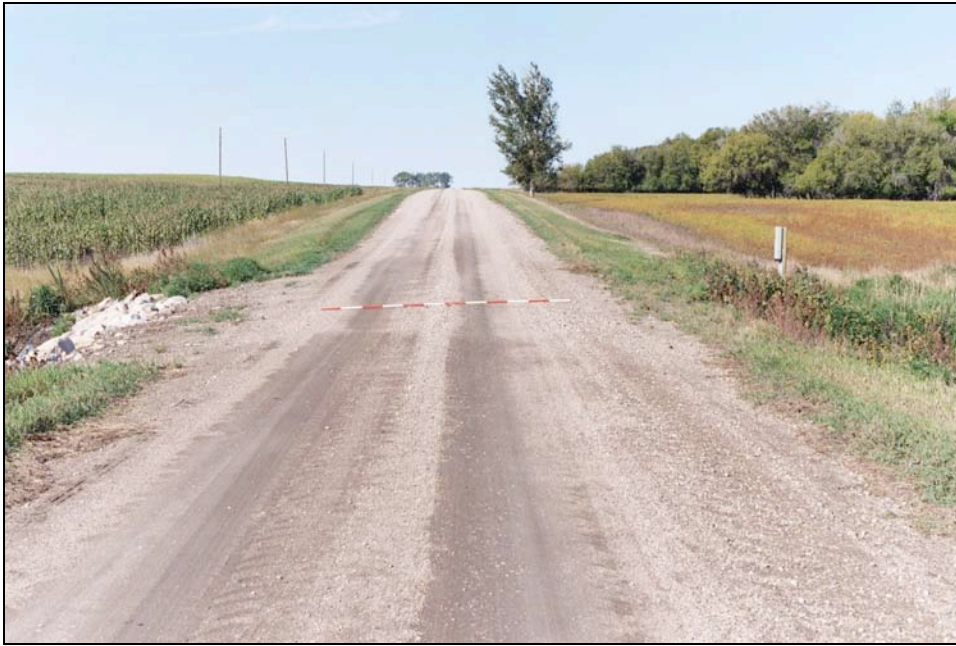
S21 Center of road crossing across four 60" CMPs, looking west (09-24-04), Section 3 & 4, T157N, R63W, N 530940.38, E 2419821.97, elevation 1498.2 @ center of road crossing, top of gravel.

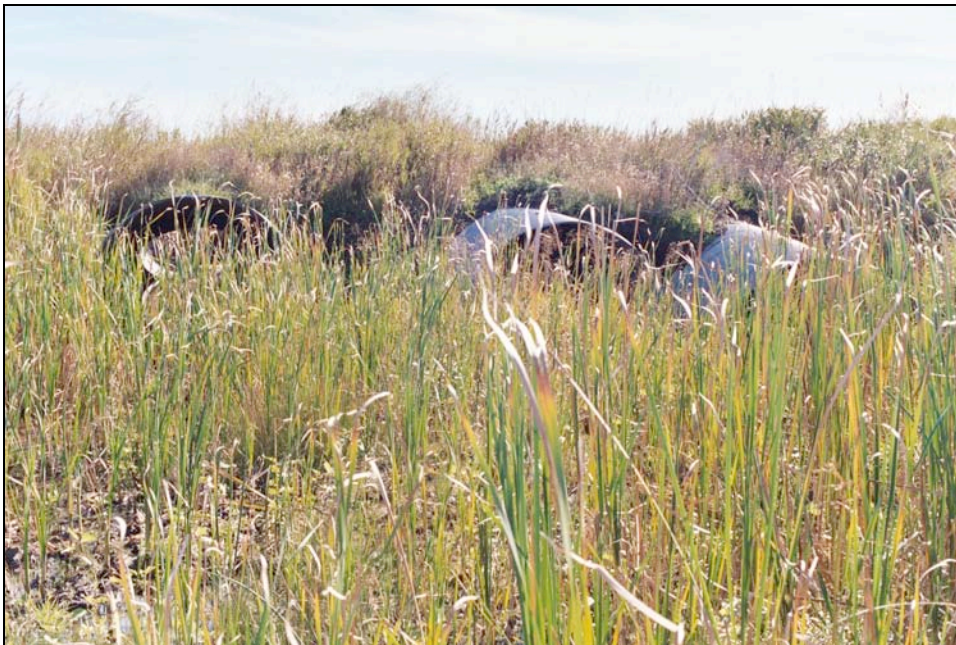
S22 Upstream side of three 60" CMPs, in poor condition, collapsed 3.1 feet, 0.8 feet & no water, from south to north (09-24-04), Section 33 & 34, T158N, R63W, N 536668.21, E 2418570.97, elevation 1492.2 @ invert of 60" CMP, N 536676.39, E 2418575.21, elevation 1493.7 @ invert of 60" CMP, N 536688.84, E 2418576.40, elevation 1494.6 @ invert of 60" CMP.

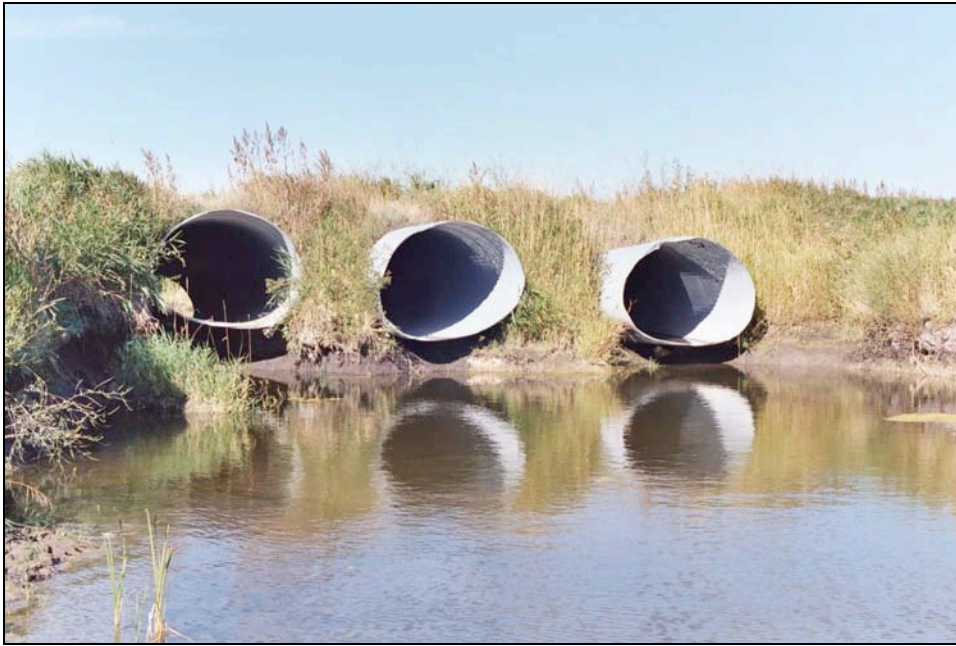
S22 Downstream side of three 60" CMPs, in poor condition, water is backup from other fork & is undercut, no water, from south to north (09-24-04), Section 33 & 34, T158N, R63W, N 536667.18, E 2418622.07, elevation 1495.3 @ invert of 60" CMP, N 536676.26, E 2418625.84, elevation 1494.8 @ invert of 60" CMP, N 536687.63, E 2418625.51, elevation 1494.2 @ invert of 60" CMP.

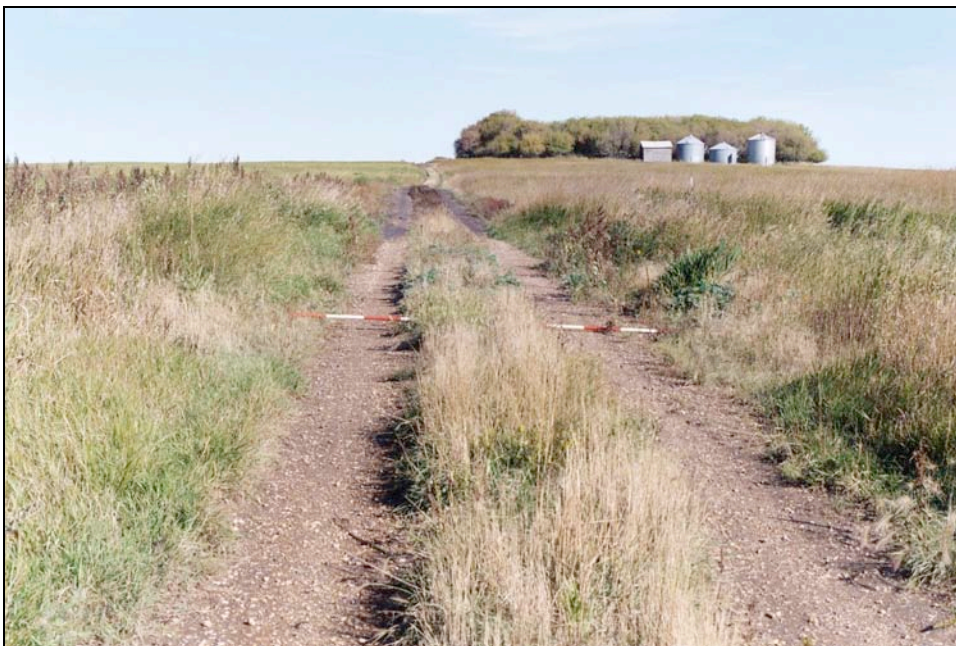
S22 Center of road crossing across three 60" CMPs, looking north (09-24-04), Section 33 & 34, T158N, R63W, N 536676.41, E 2418601.95, elevation 1501.0 @ center of trail crossing, top of ground.

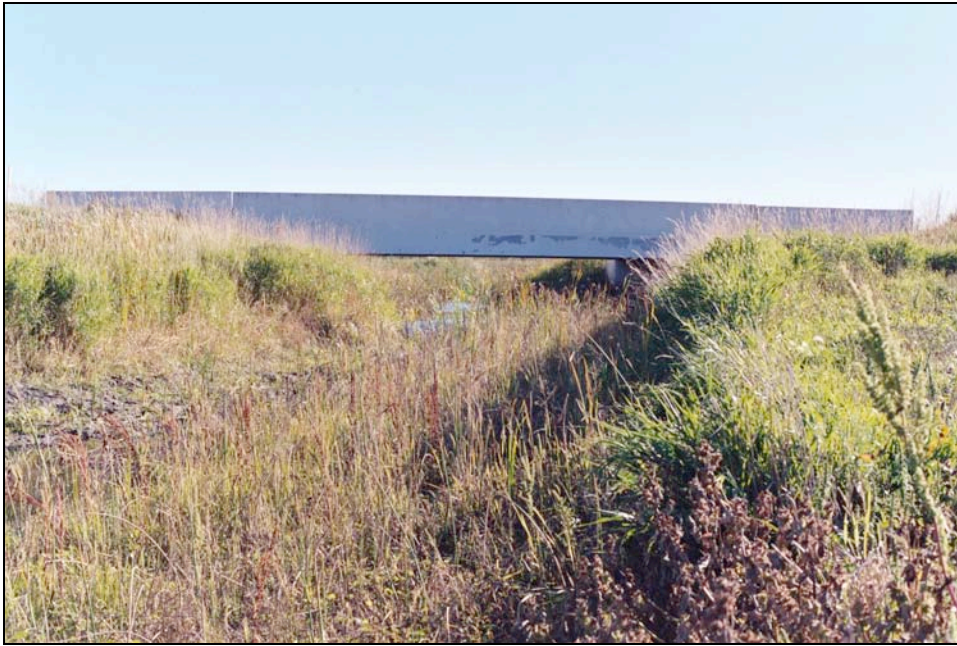
S23 Upstream side of concrete bridge, in new condition 2.2 feet of water (09-28-04), Section 28 & 33, T158N, R63W, N 541399.19, E 2414512.49, coulee bottom elevation 1496.4 @ C/L of bridge.

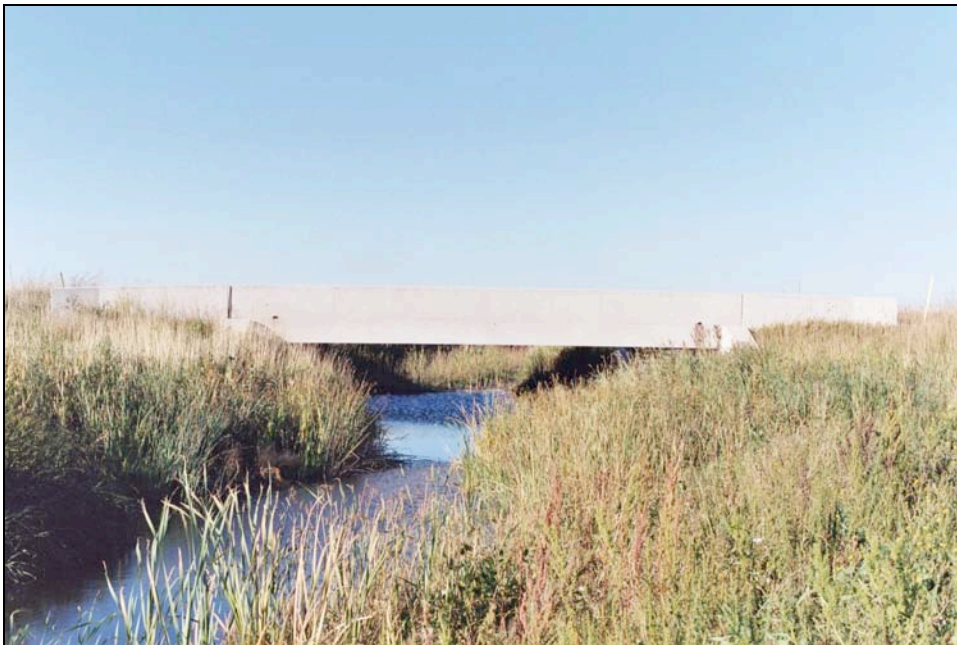
S23 Downstream side of concrete bridge, in new condition, 2.1 feet of water (09-28-04), Section 28 & 33, T158N, R63W, N 541366.94, E 2414510.02, coulee bottom elevation 1496.4 @ C/L of bridge.

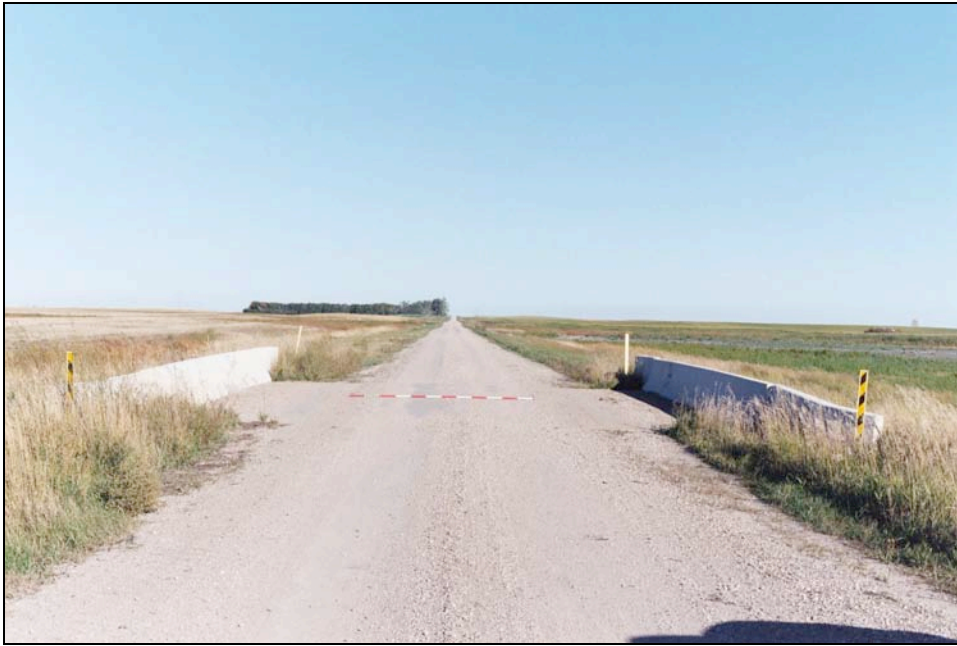
S23 Center of concrete bridge, looking east in new condition, 32.0 feet wide & 42.0 feet long (09-28-04), Section 28 & 33, T158N, R63W, N 541383.19, E 2414512.97, elevation 1507.3 @ C/L of bridge, top of concrete.

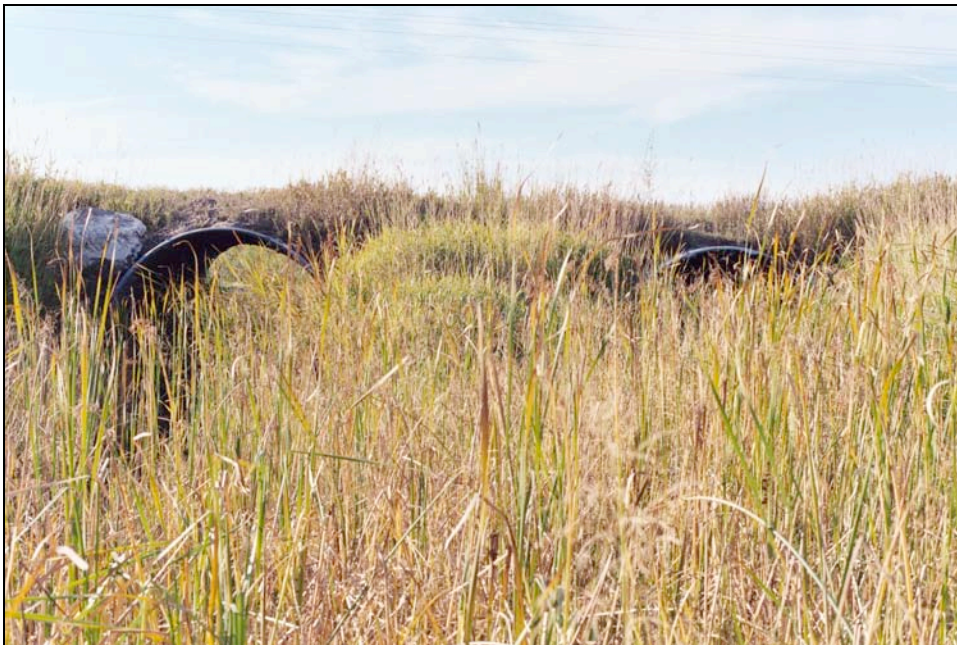
S24 Upstream side of two 72" CMPs, in good condition, 0.1 feet of water & no water, east to west (09-29-04), Section 20 & 29, T158N, R63W, N 546626.00, E 2411209.26, elevation 1502.9 @ invert of 72" CMP, N 546625.04, E 2411190.77, elevation 1503.0 @ invert of 72" CMP.

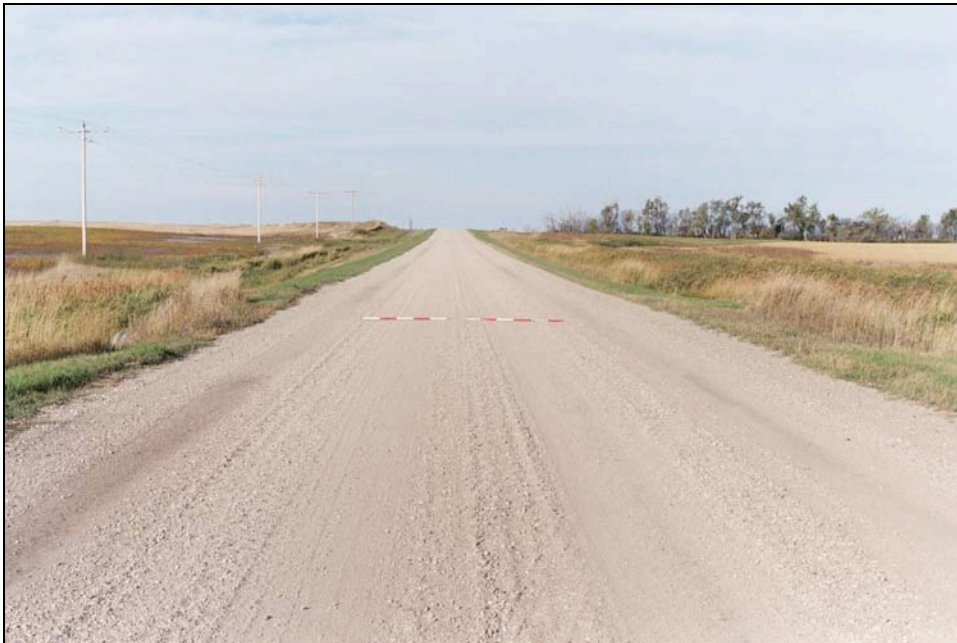
S 24 Center of road crossing across two 72" CMPs, looking west (09-29-04), Section 20 & 29, T158N, R63W, N546595.98, E 2411202.08, elevation 1511.1 @ center of road crossing, top of gravel.

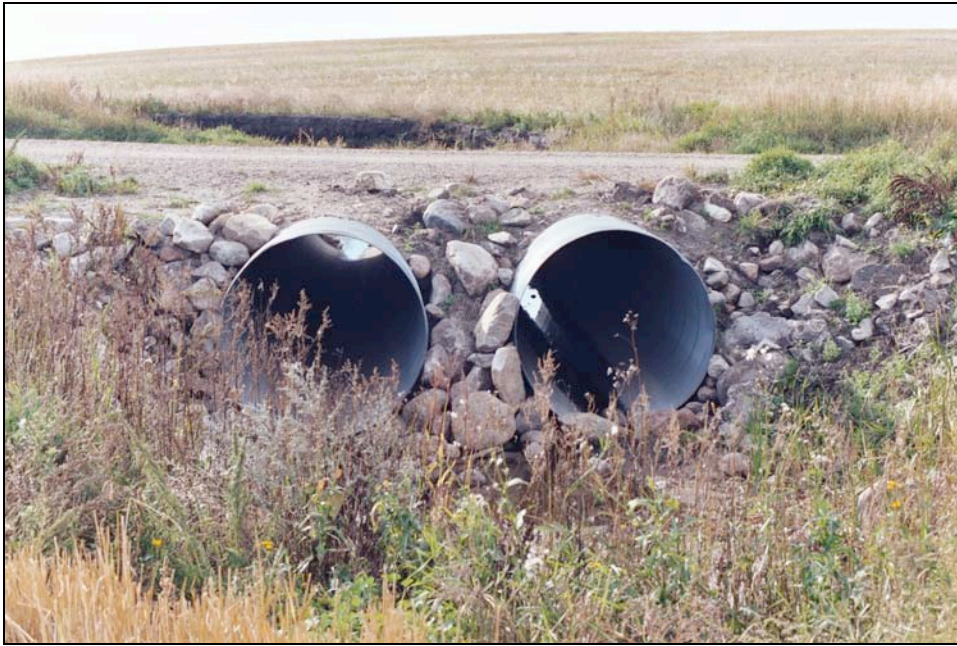
S25 Upstream side of two 72" CMPs, in good condition, no water & no water,
east to west (09-29-04), Section 5 & 8, T158N, R63W,
N 562430.05, E 2409628.60, elevation 1522.3@ invert of 72" CMP,
N 562427.39, E 2409620.56, elevation 1522.2@ invert of 72" CMP.

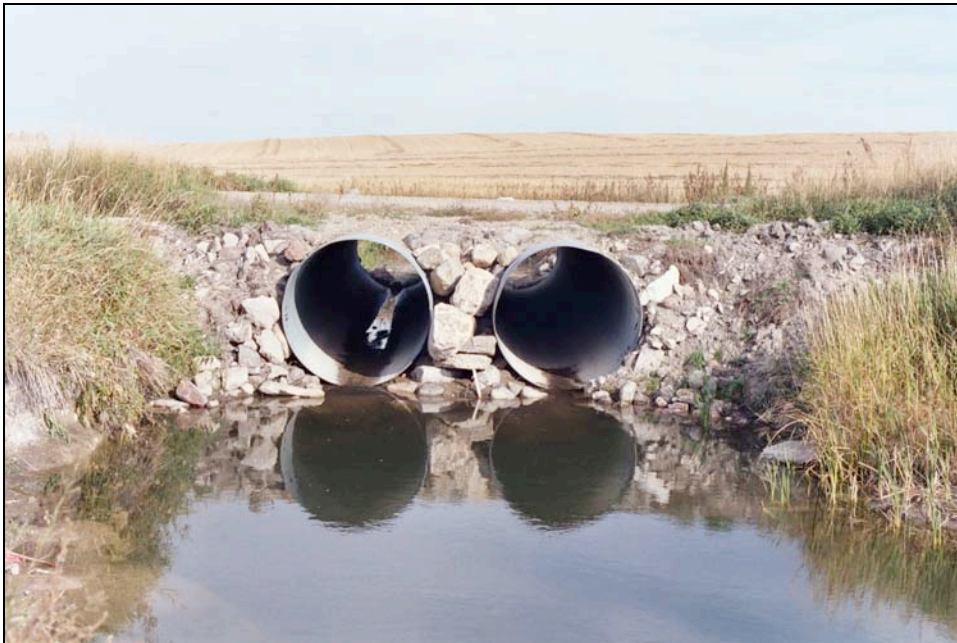
S25 Downstream side of two 72" CMPs, in good condition, no water & no water,
east to west (09-29-04), Section 5 & 8, T158N, R63W,
N 562385.07, E 2409640.85, elevation 1522.0 @ invert of 72" CMP,
N 562382.45, E 2409632.55, elevation 1522.1 @ invert of 72" CMP.

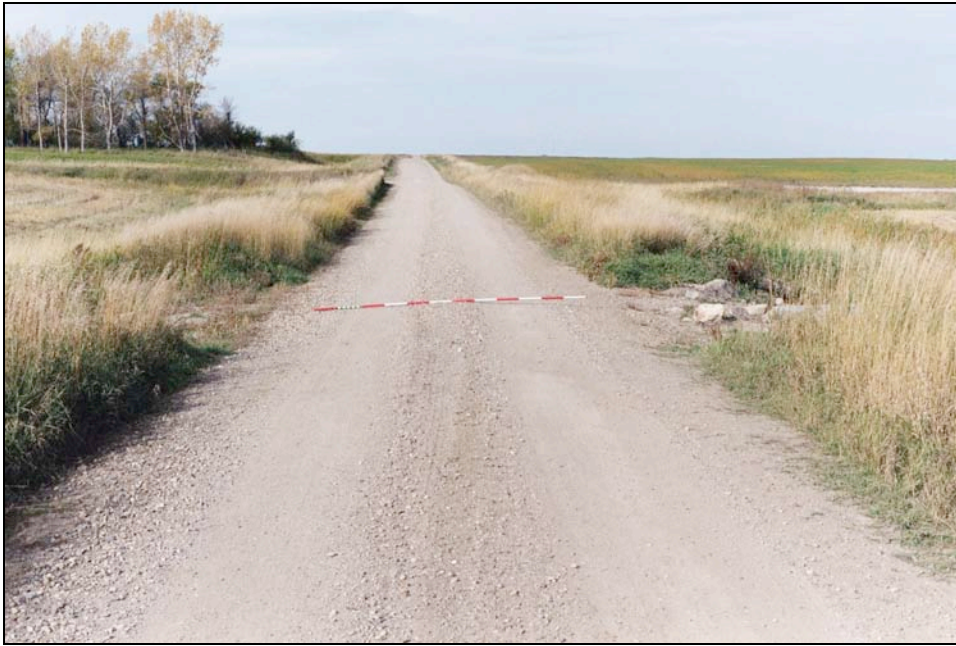
S25 Center of road crossing two 72" CMPs, looking west (09-29-04), Section 5 & 8, T158N, R63W, N 562406.84, E 2409630.40, elevation 1529.3 @ center of road crossing, top of gravel.

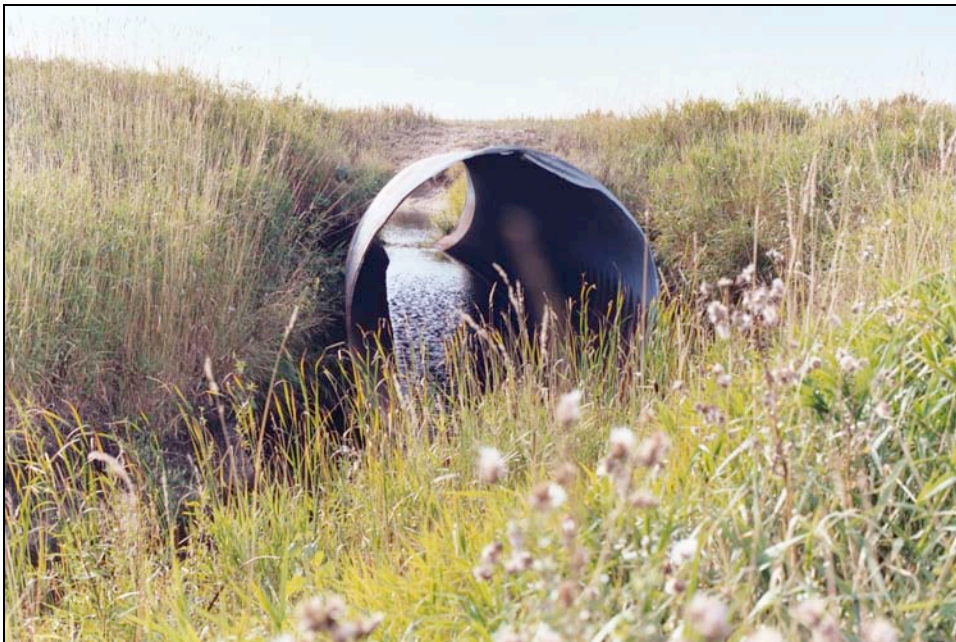
S26 Upstream side of one 120" CMP, in good condition, 0.9 feet of water (09-29-04), Section 32 & 5, T158 & 159N, R63W, N 567721.77, E 2410233.21, elevation 1529.8 @ invert of CMP.

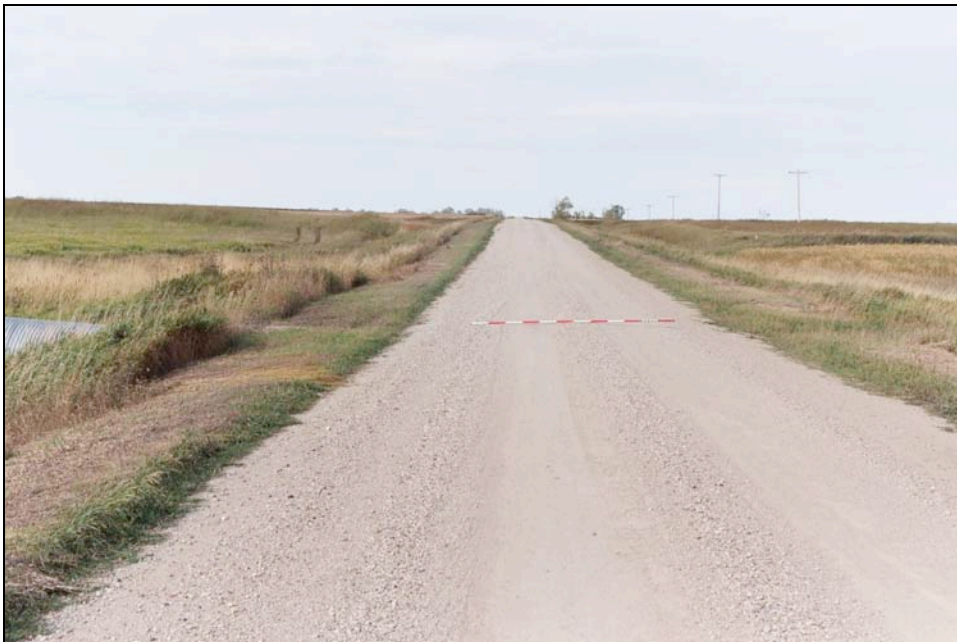
S26 Center of road crossing across on 120" CMP, looking west (09-29-04), Section 32 & 5, T158 & 159N, R63W, N 567680.30, E 2410233.86, elevation 1541.1 @ center of road crossing, top of gravel.

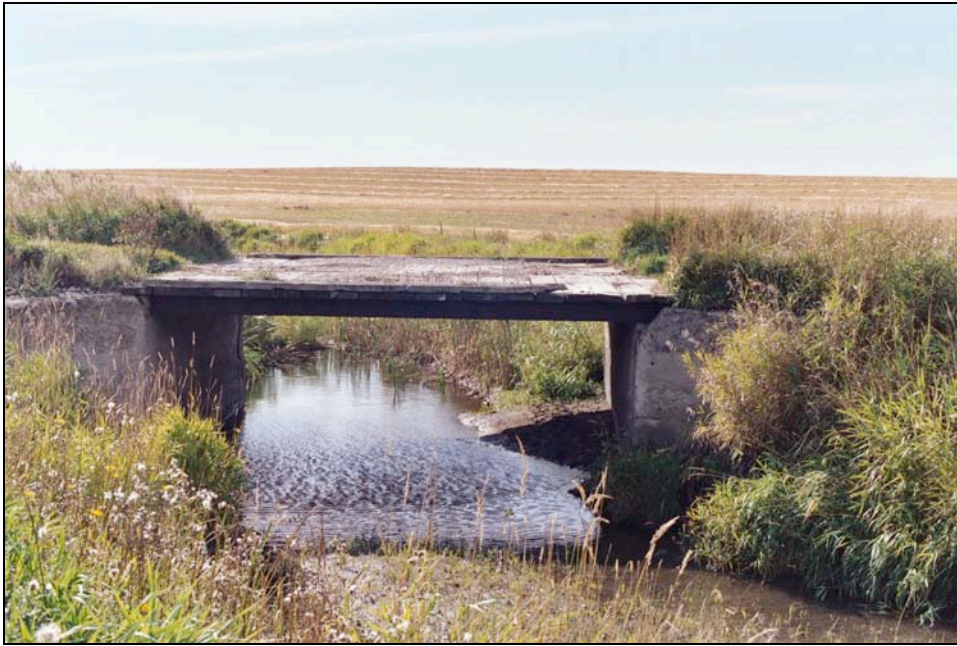
S27 Upstream side of wood & concrete bridge, in poor condition, 1.0 feet of water (09-29-04), Section 29 & 32, T159N, R63W, N 572923.99, E 2407974.02, elevation 1535.6 @ coulee bottom.

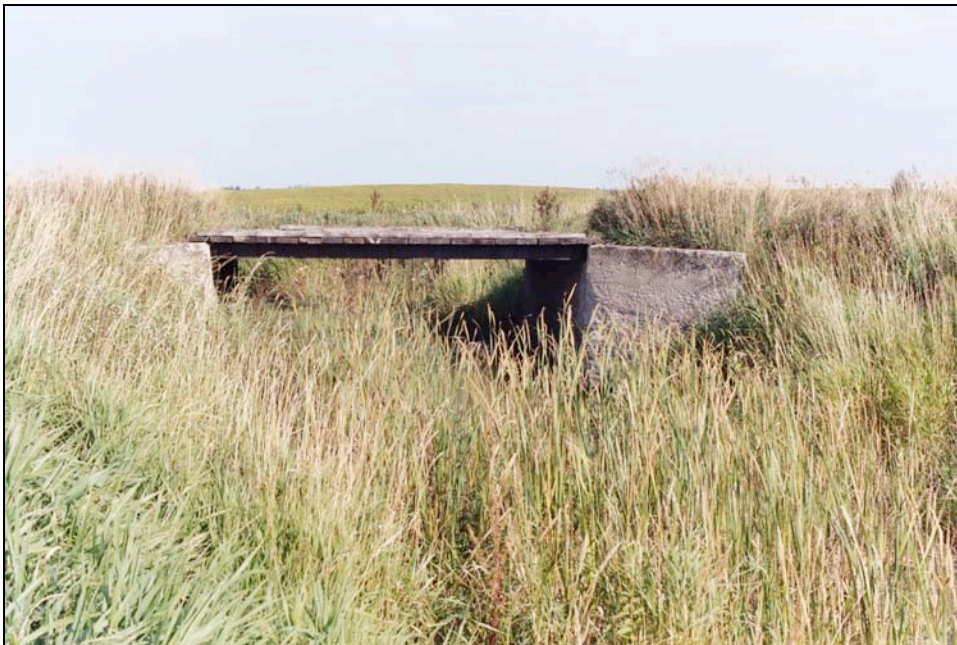
S27 Downstream side of wood & concrete bridge, in poor condition, 1.1 feet of water (09-29-04), Section 29 & 32, T159N, R63W, N 572903.94, E 2407976.76, elevation 1534.5 @ coulee bottom.

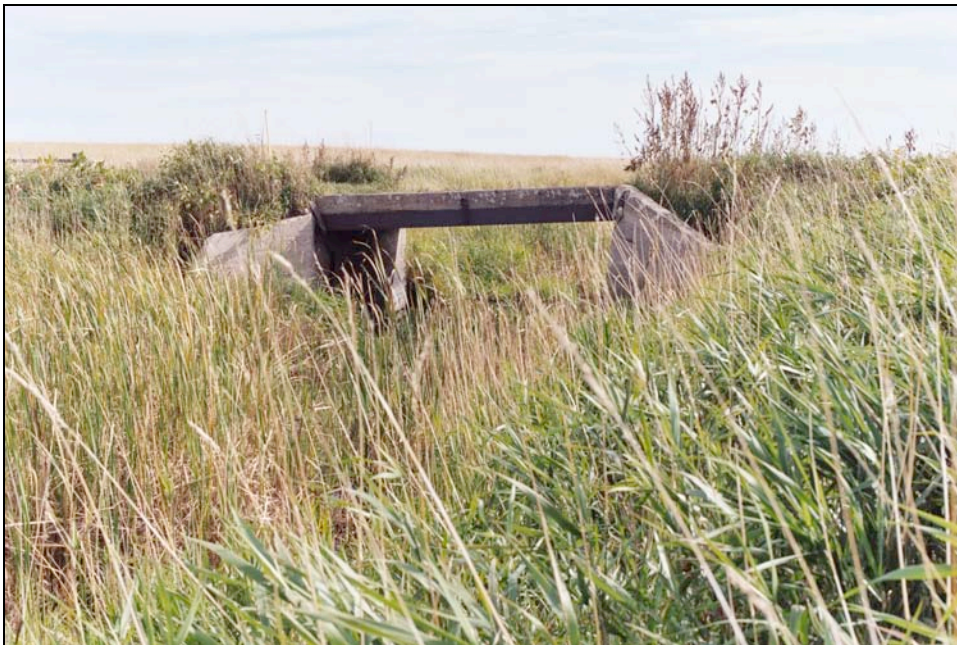
S28 Upstream side of concrete bridge, in poor condition, 0.9 feet of water (09-29-04), Section 30 & 29, T159N, R63W, N 576614.76, E 2407080.82. coulee bottom elevation 1541.6 @ C/L of bridge.

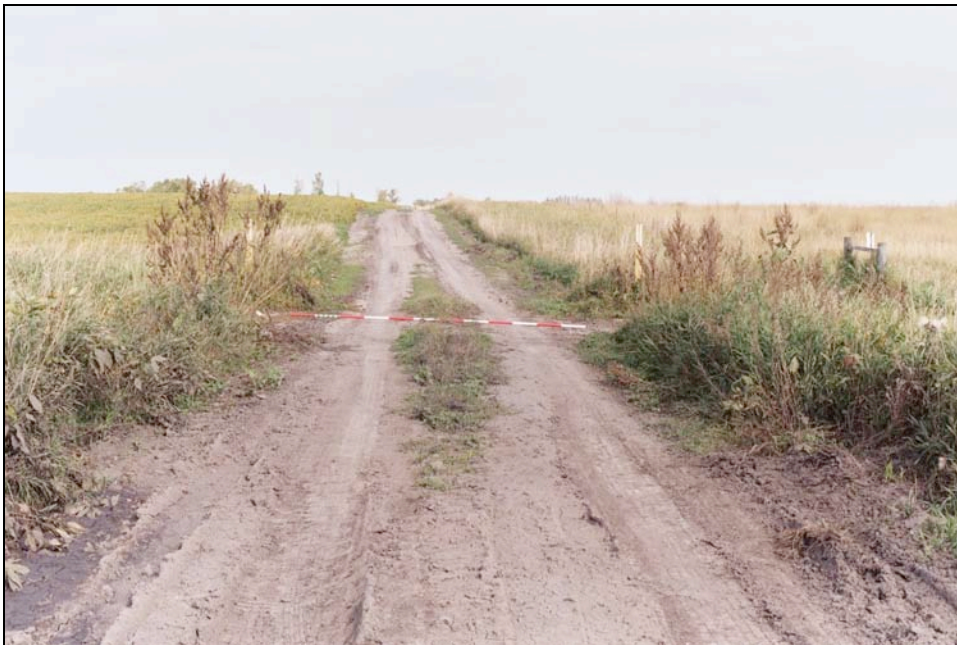
S29 Center of concrete bridge, looking north, in poor condition, 18.0 feet wide & 15.0 feet long (09-29-04), Section 30 & 29, T159N, R63W, N 576614.96, E 2407089.51, elevation 1549.4 @ C/L of bridge, top of concrete.

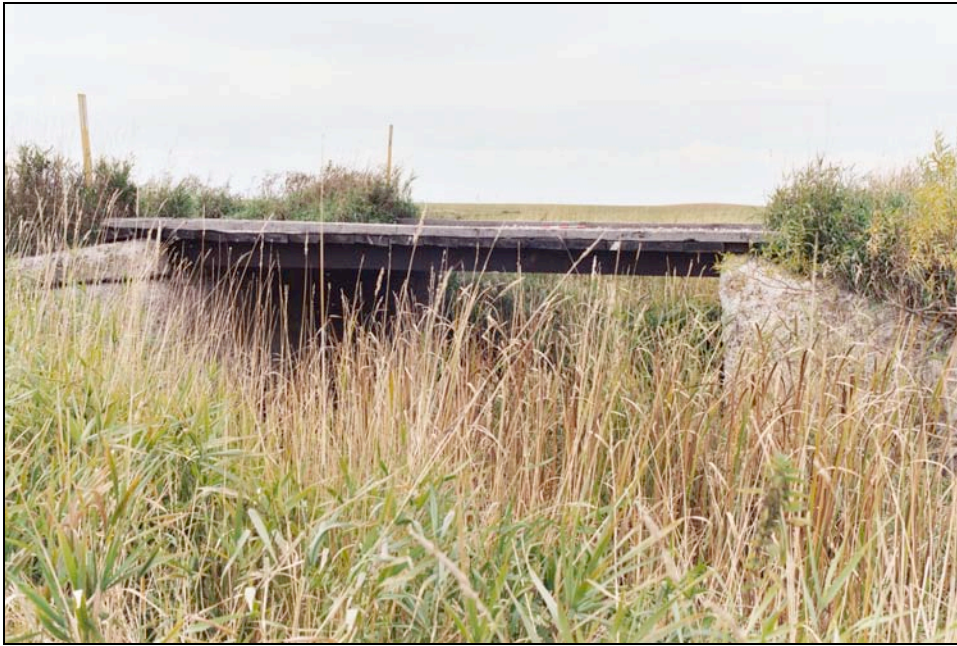
S29 Upstream side of wood & concrete bridge, in poor condition, 1.5 feet of water (09-29-04), Section 30 & 29, T159N, R63W, N 577663.17, E 2407075.68, elevation 1542.6 @ coulee bottom.

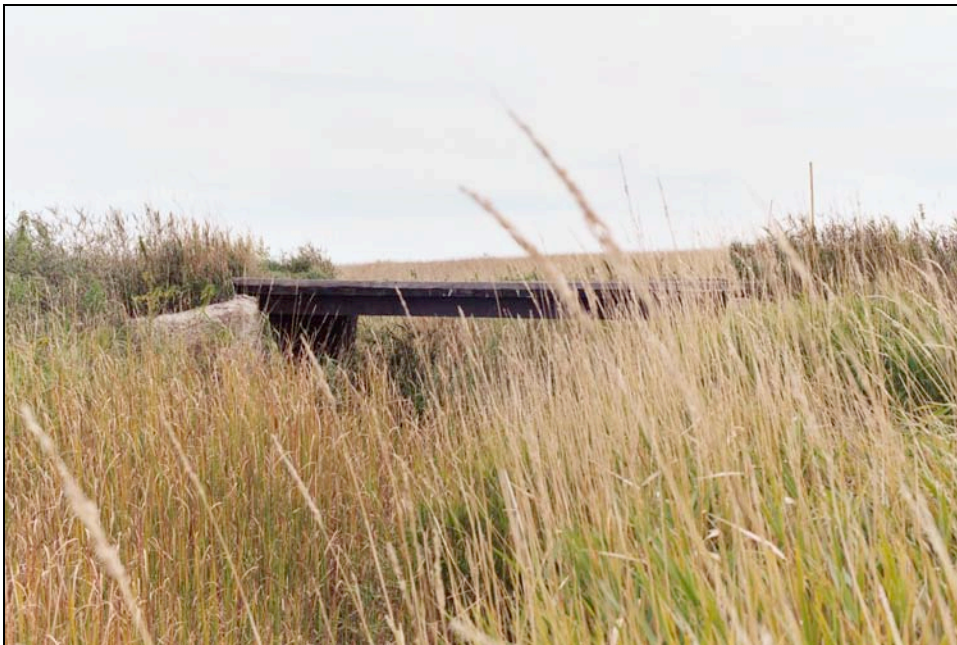
S29 Downstream side of wood & concrete bridge, in poor condition, no water (09-29-04), Section 30 & 29, T159N, R63W, N 577660.87, E 2407055.22, elevation 1544.5 @ coulee bottom.

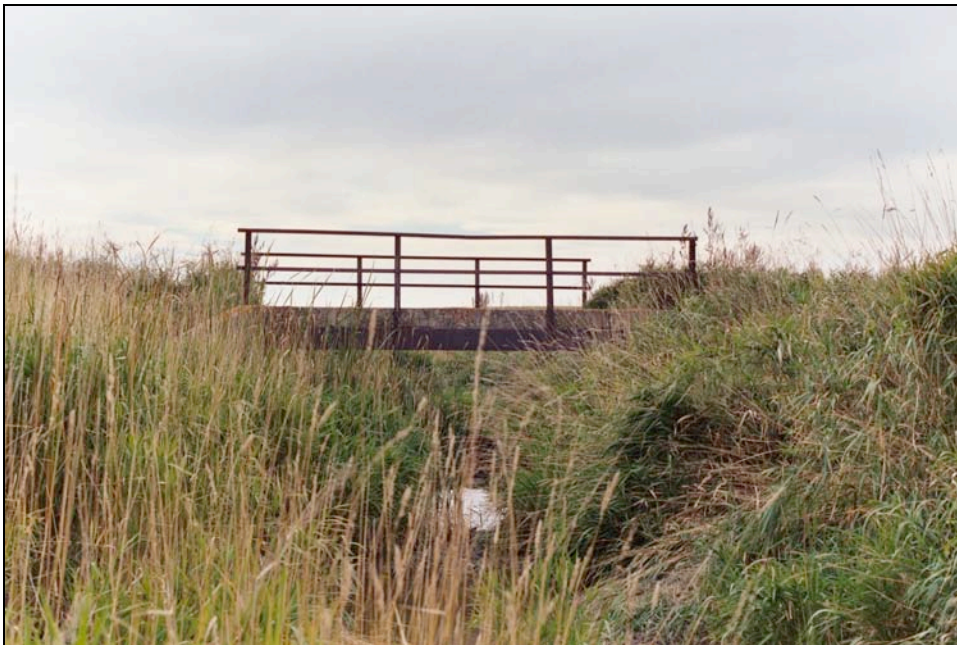
S30 Upstream side of concrete bridge, in poor condition, 0.8 feet of water (09-29-04), Section 19 & 30, T159N R63W, N 578153.63, E 2405475.61, elevation 1543.2 @ coulee bottom.

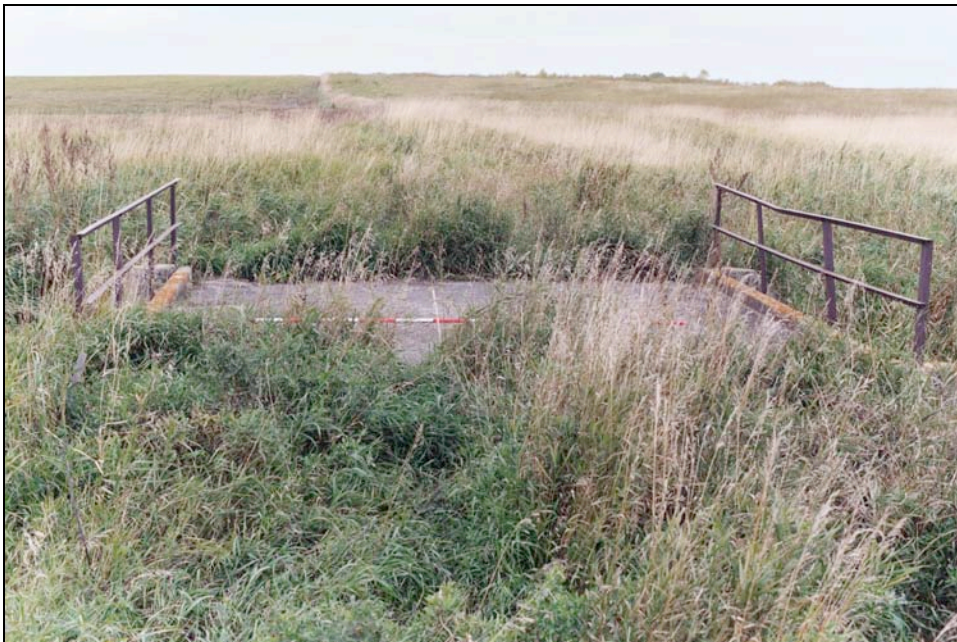
S30 Center of concrete bridge, looking west in poor condition, 18.0 feet wide & 18.0 feet long (09-29-04), Section 19 & 30, T159N, R63W, N 578144.37, E 2405475.29, elevation 1550.3 @ C/L of bridge, top of concrete.

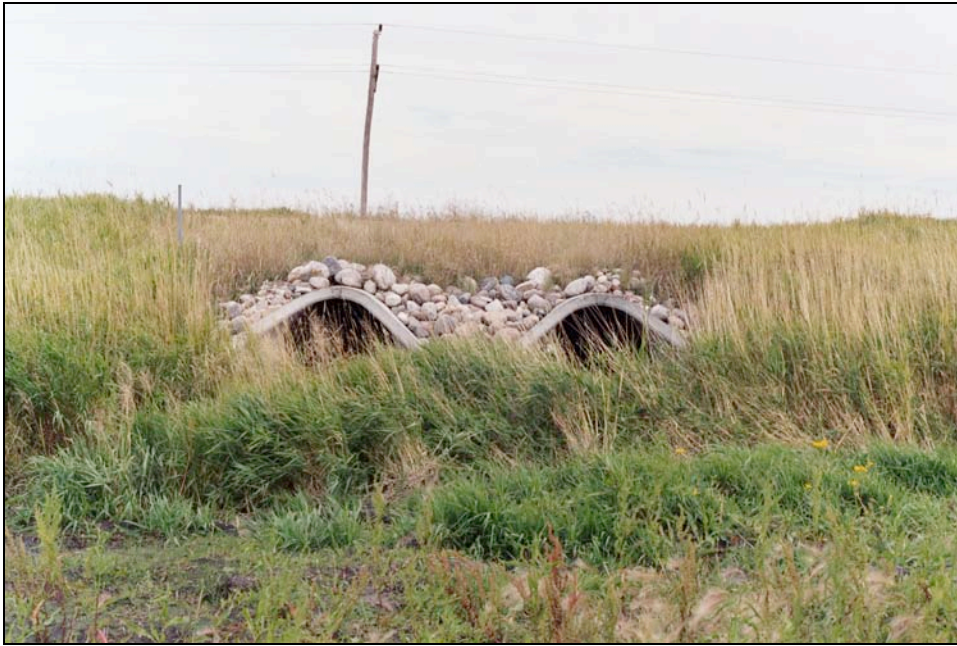
S31 Upstream side of two 60" concrete pipes, in good condition, south to north, no water @ invert of concrete pipe & 0.1 feet of water @ invert of concrete pipe (09-29-04), Section 24 & 19, T159N, R63 & 64W, N 582613.67, E 2401692.08, elevation 1551.2 @ invert of 60" concrete pipe, N 582623.80, E 2401692.80, elevation 1551.2 @ invert of 60" concrete pipe.

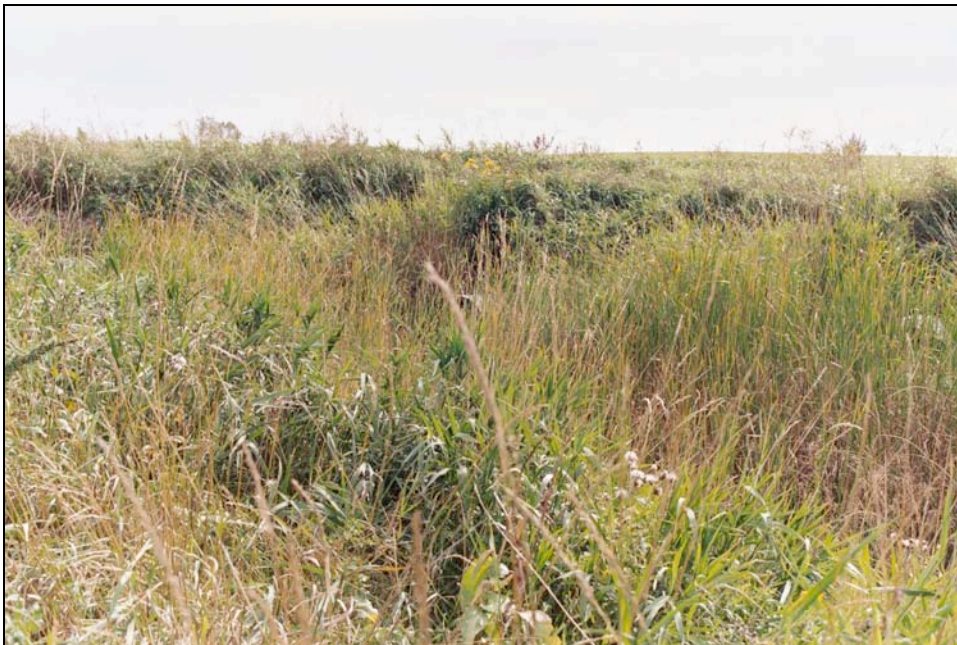
S32 Upstream side of three 36" CMPs, in good condition, 0.1 feet, 0.6 feet, & 0.6 feet of water, from east to west (09-29-04), Section 13 & 24, T159N, R64W N 583363.62, E 2401188.82, elevation 1551.5 @ invert of 36" CMP, N 583362.66, E 2401171.74, elevation 1551.1 @ invert of 36" CMP, N 583361.61, E 2401156.32, elevation 1551.2 @ invert of 36" CMP.

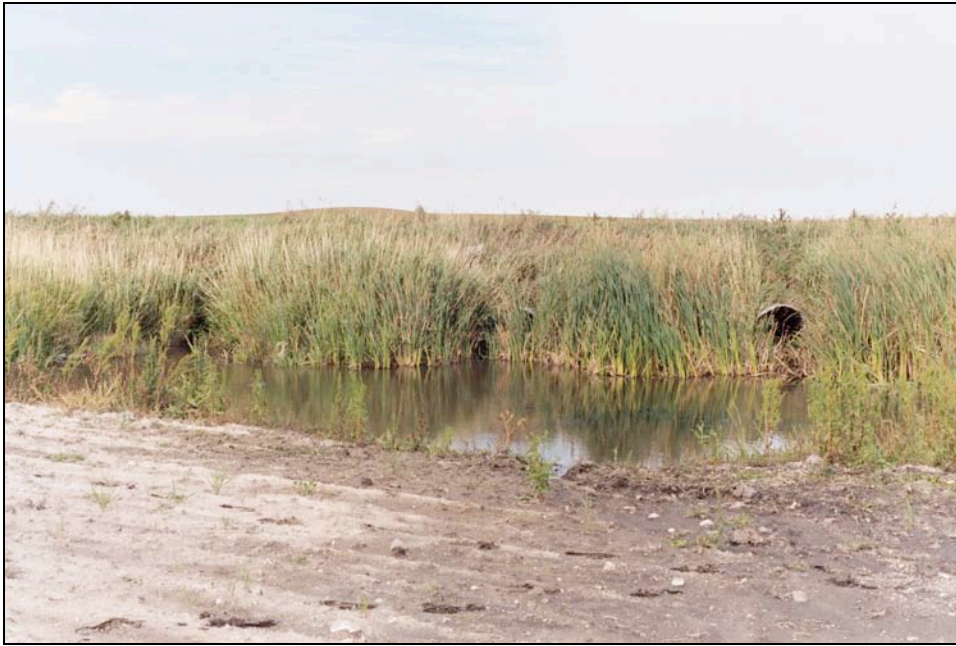
S32 Downstream side of three 36" CMPs, in good condition, 0.2 feet, 0.7 feet & 0.1 feet of water, from east to west (09-29-04), Section 13 & 24, T159N R64W, N 583312.41, E 2401188.61, elevation 1551.2 @ invert of 36" CMP, N 583311.16, E 2401173.17, elevation 1550.8 @ invert of 36" CMP, N 583310.70, E 2401155.57, elevation 1551.5 @ invert of 36" CMP.

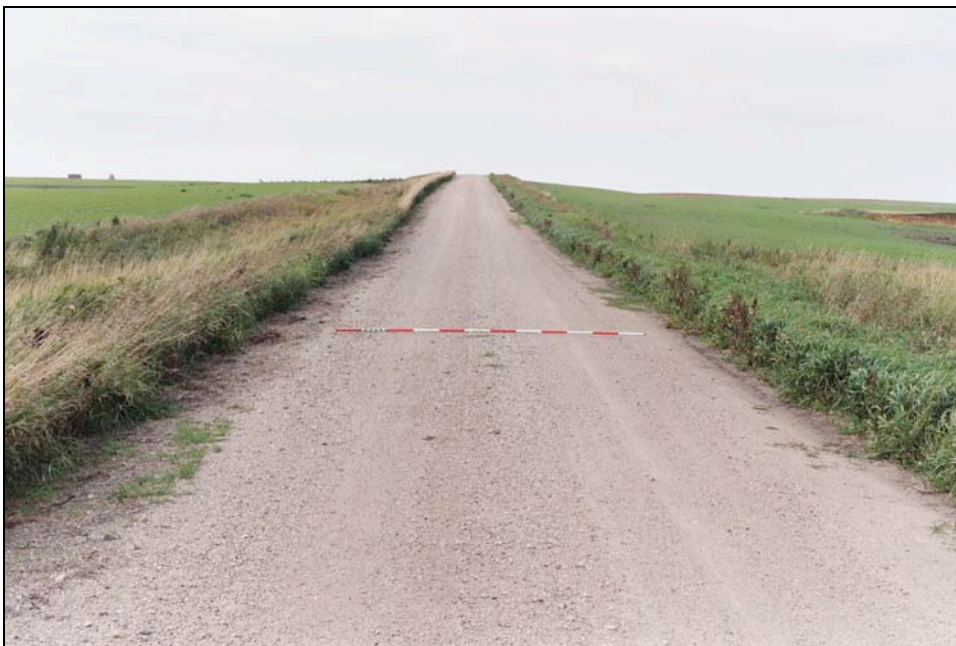
S32 Center of road crossing across three 36" CMPs, looking west (09-29-04), Section 13 & 24, T159N, R64W, N 583335.90, E 2401172.19, elevation 1558.0 @ center of road crossing, top of gravel.

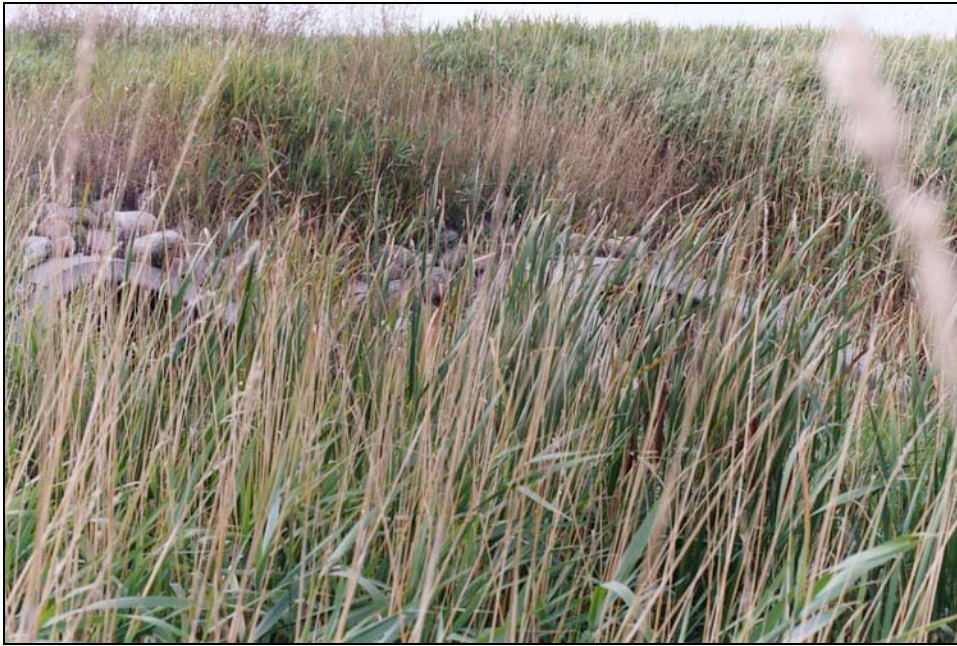
S33 Upstream side of two 60" concrete pipes, in good condition, 0.3 feet of water & 0.3 feet of water, @ invert of concrete pipes, south to north (09-29-04), Section 13 & 18, T159N, R64 & 63W, N 587871.95, E 2401665.59, elevation 1558.2 @ invert of 60" concrete pipe, N 587882.44, E 2401664.42, elevation 1558.2 @ invert of 60" concrete pipe.

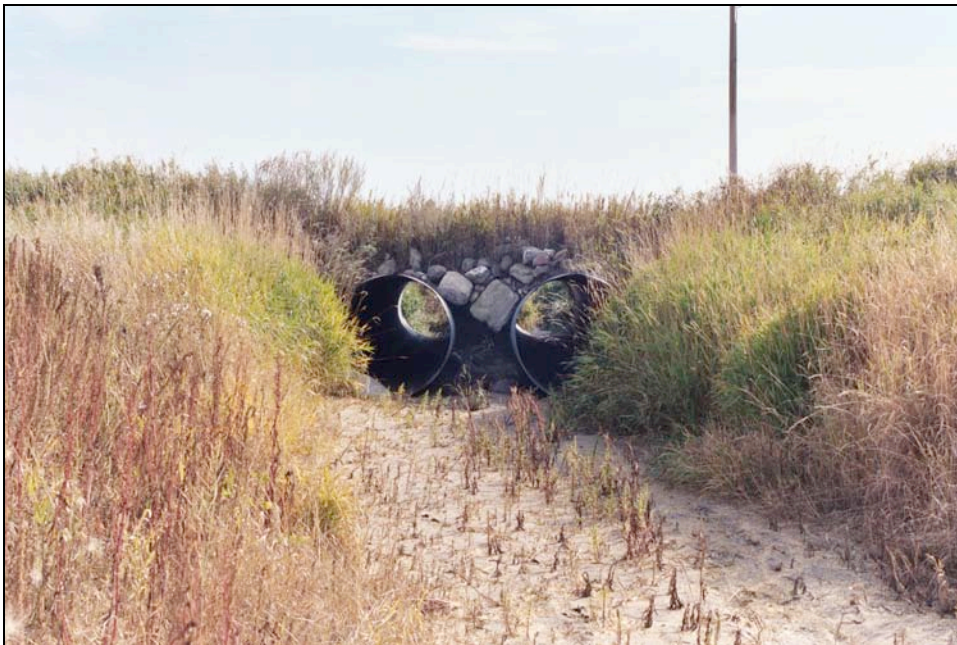
S34 Upstream side of two 60" CMPs, in good condition, no water (09-29-04), Section 6 & 7, T159N, R63W, N 593937.73, E 2402427.24, elevation 1564.9 @ invert of 60" CMP, N 593937.20, E 2402419.44, elevation 1564.9 @ invert of 60" CMP.

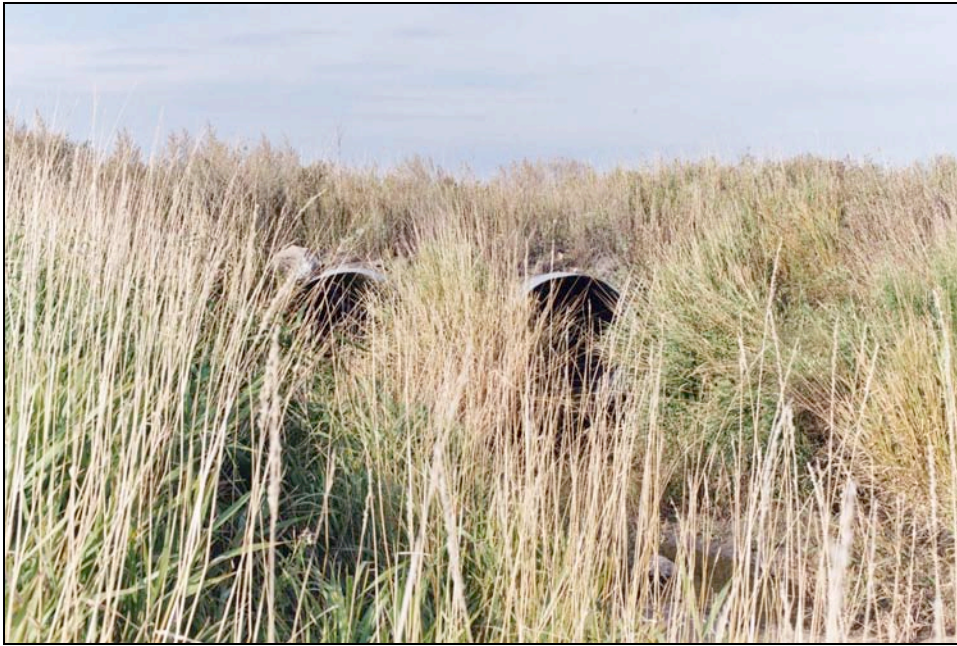
S34 Downstream side of two 60" CMPs, in good condition, no water (09-29-04), Section 6 & 7, T159N, R63W, N 593887.62, E 2402434.46, elevation 1564.6 @ invert of 60" CMP, N 593886.78, E 2402426.91, elevation 1564.8 @ invert of 60" CMP.

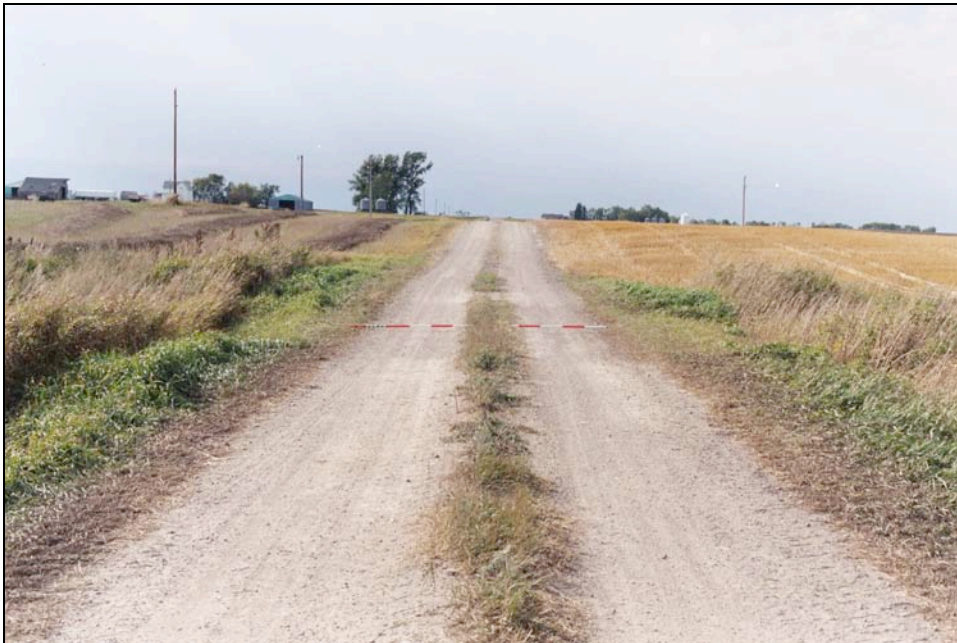
S34 Center of road crossing across two 60" CMPs, looking west (09-29-04), Section 6 & 7, T159N, R63W, N 593912.07, E 2402428.20, elevation 1573.0 @ center of road crossing, top of gravel.

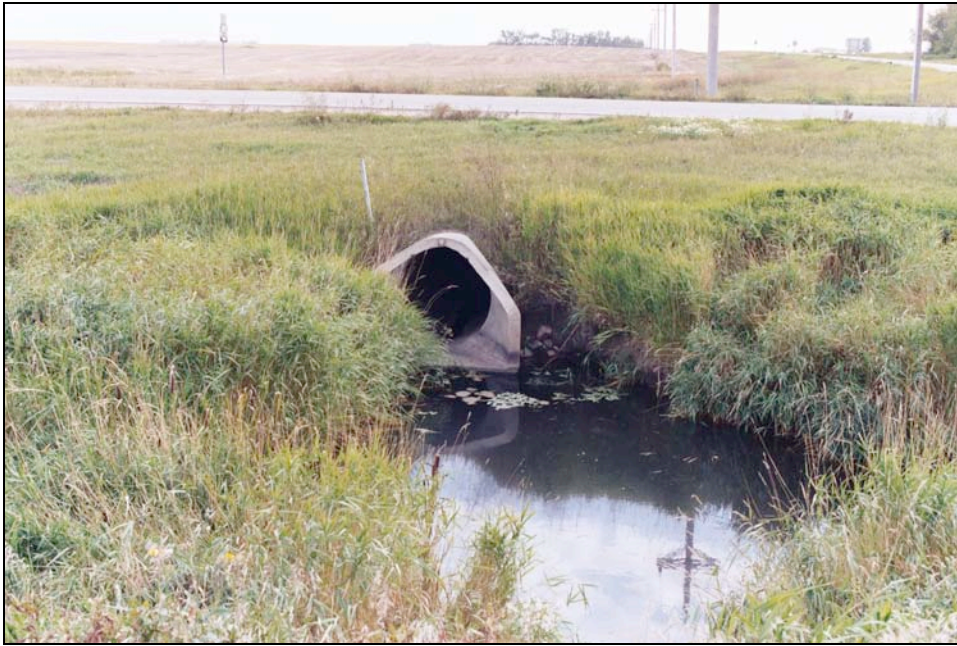
S35 Upstream side on one 60" concrete pipe, in good condition, no water (09-29-04), Section 31 & 6, T159 & 160N, R63W, N599196.61, E 2401506.63, elevation 1572.2 @ invert of concrete pipe.

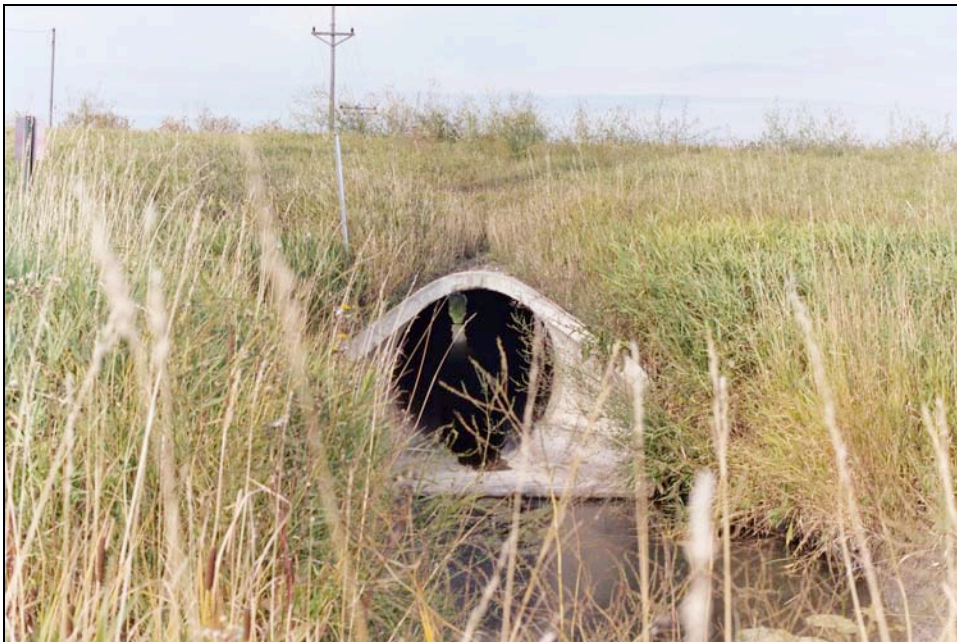
S35 Downstream side of one 60" concrete pipe, in good condition, no water (09-29-04), Section 31 & 6, T159 & 160N, R63W, N 59907.52, E 2401505.52, elevation 1572.0 @ invert of concrete pipe.
